Reporting on a Large Ocean Inlet Crossing Live Transmission Line Inspection Performed by LineScout Technology

Serge Montambault^{*†}, Nicolas Pouliot[†], Janos Toth[◇], Bernhard Spalteholz[∞]

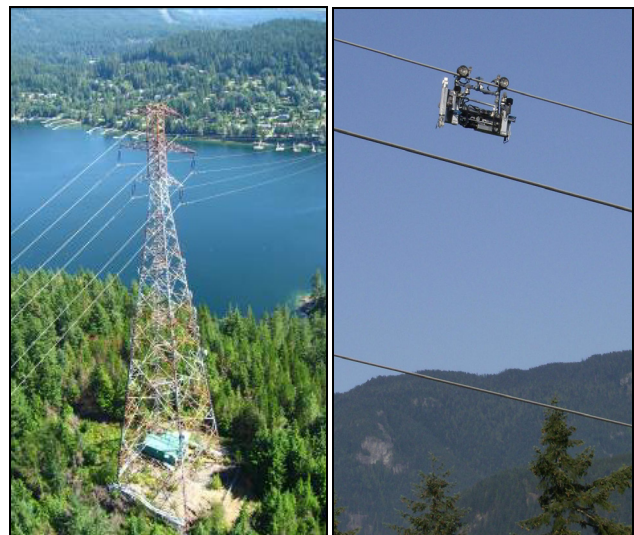
The transmission line spans that were to be inspected are among the most spectacular in North America (see Fig. 1). It comprises six conductors about 15 m apart that spear over a water inlet for 1260 m until they reach the 100 m-high middle tower, erected on a peninsula. The second span is even longer, with 1690 m, until it ends at a supporting tower setup on a steep cliff. Access to the sites was possible with 4x4 high-clearance vehicles so the overall robustness and portability of LineScout was extensively validated.

Fig. 1. A mid tower on the 3.0 km crossing, LineScout in action
